# Manhole Inspection Summary

Manhole # S11O\_\_030MH

Insp Date: **4/14/08 1:02 PM**

**Location** Address: **3211 Kingsley St**

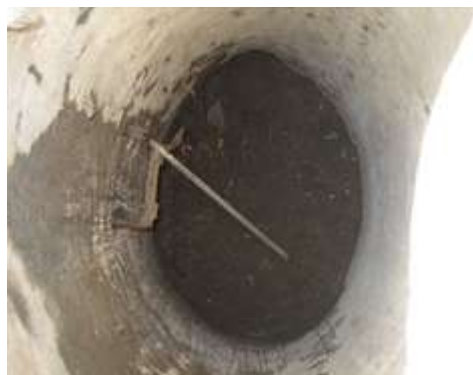
Top View

infiltration at corbel and barrel, sediment on bottom

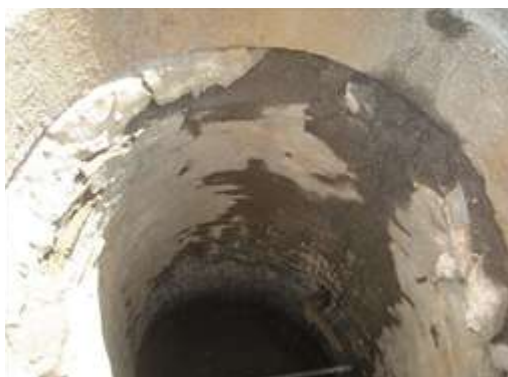
Defect 4

offset frame 3.5" with infiltration from underneath frame at Chimney and corbel

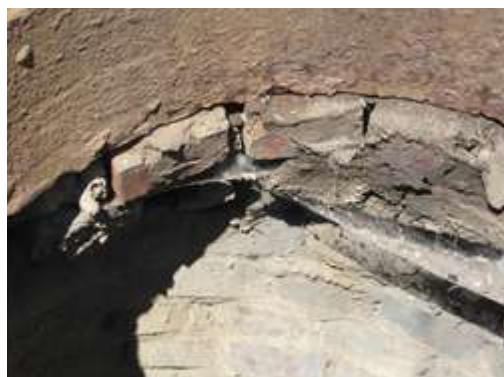
Defect 5

cracked and loose bricks under frame

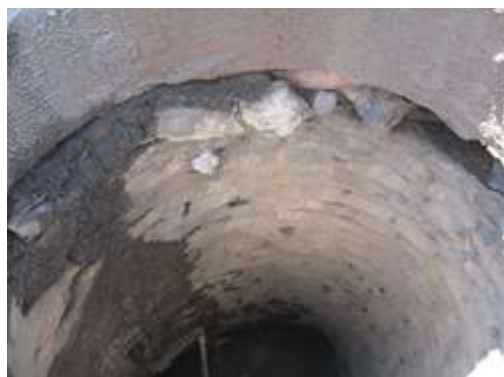
Defect 3

missing and loose bricks and mortar under chimney

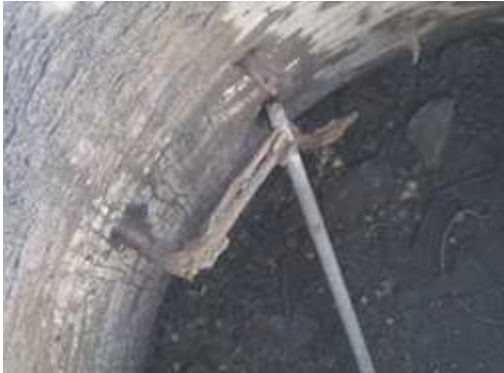
Defect 2

Corroded steps and barrel infiltration

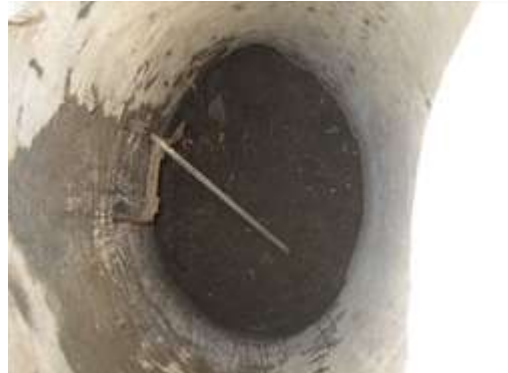
Defect 6

channel debris

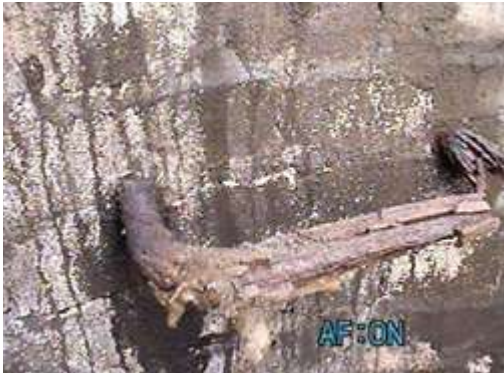
Defect 1

infiltration around corroded step

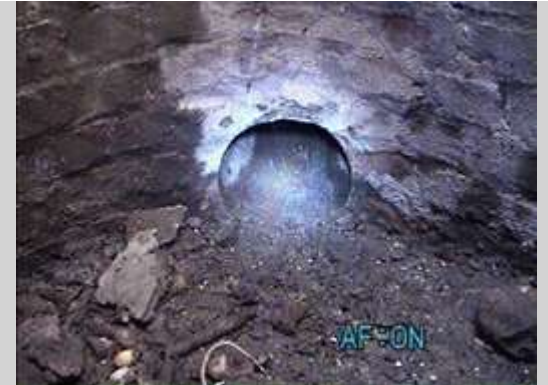
12 O'Clock Outflow

Barrel infiltration

Deposits: ☐ None ☐ Mud ☒ Gravy ☒ Debris ☐ Grease

Silt Depth: **4** (in.) Deposits Extent: **Heavy**
